Re: Land Bank Act Resolution

Standardized Inspector Report (SIR)
Maintenance Disposition and Reuse Plan (MDR Plan)
 Buffalo, Erie, Niagara Land Improvement Corporation (BENLIC)

*Re: 66 Burch Ave.
West Seneca, NY 14210*

This letter is in regard to the property commonly known as 66 Burch Ave West Seneca, NY 14210 SBL# 133.35-1-33. The property is currently vacant and after review of our files has been since approximately 2010. Multiple violations still exist at the property (See attached photos). After several attempts to make contact to remedy the issues, still nothing has been done. The West Seneca Code Enforcement Office has been taking care of lawn maintenance for the past several years. With new developments and homes being improved in the area, this creates a serious nuisance on the neighborhood. Our department receives numerous calls and complaints regarding the condition of the property and including break-ins on multiple occasions. Along with over \$20,000 owed back in taxes, this would be an excellent property for BENLIC to take over. The rehab for this single family house would cost approximately \$30,000. Thanking you in advance.

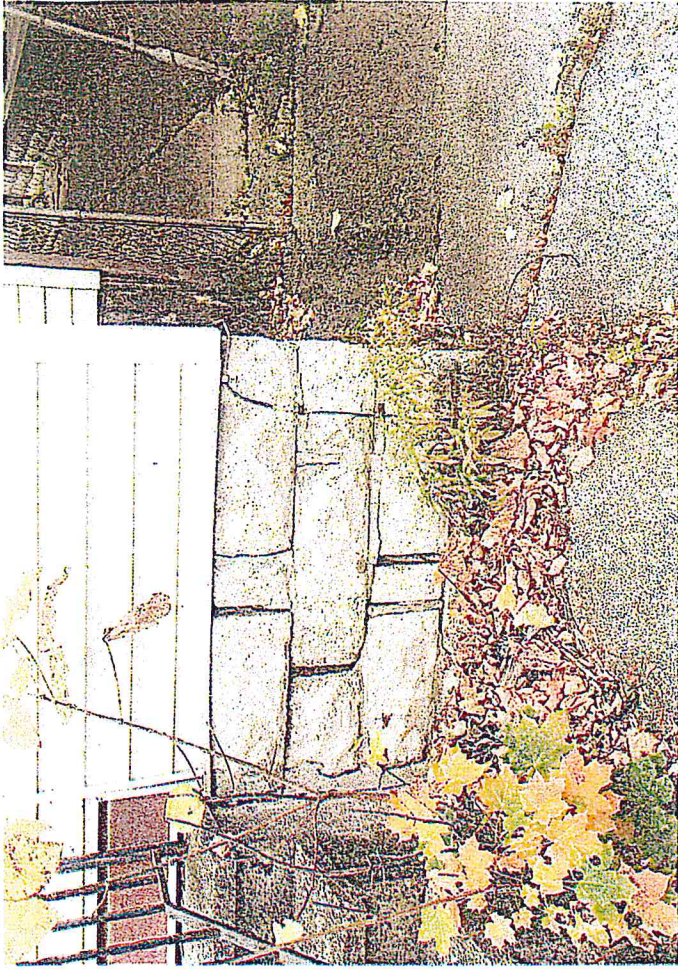
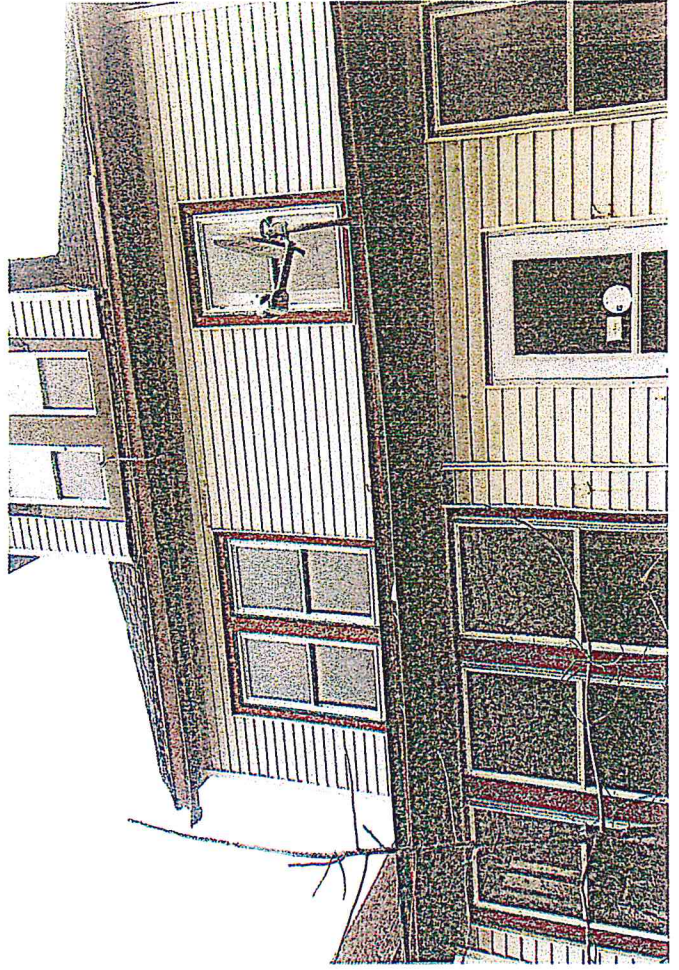
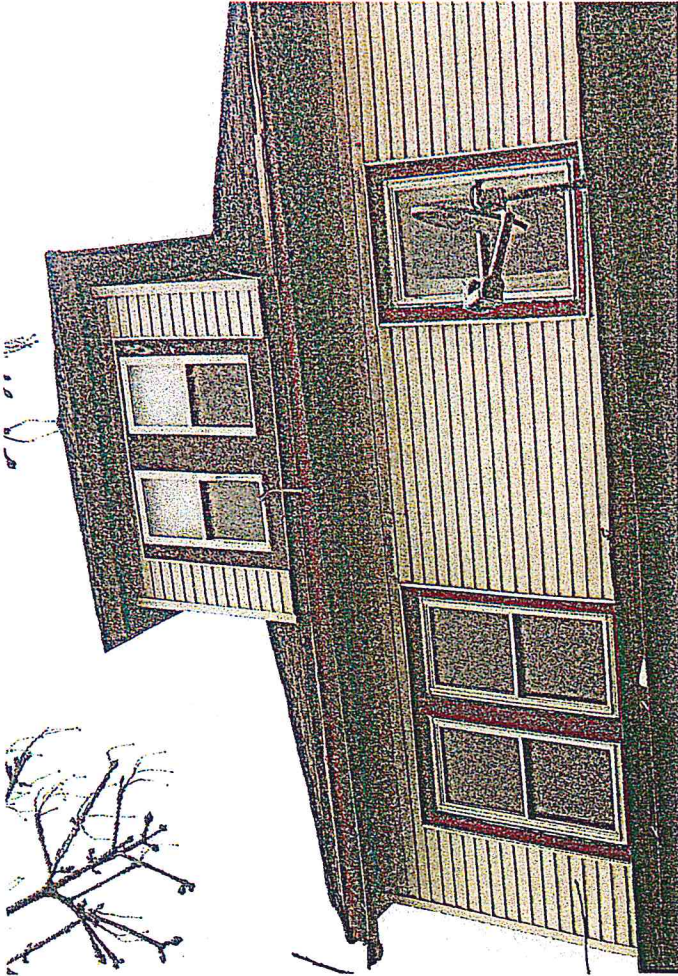
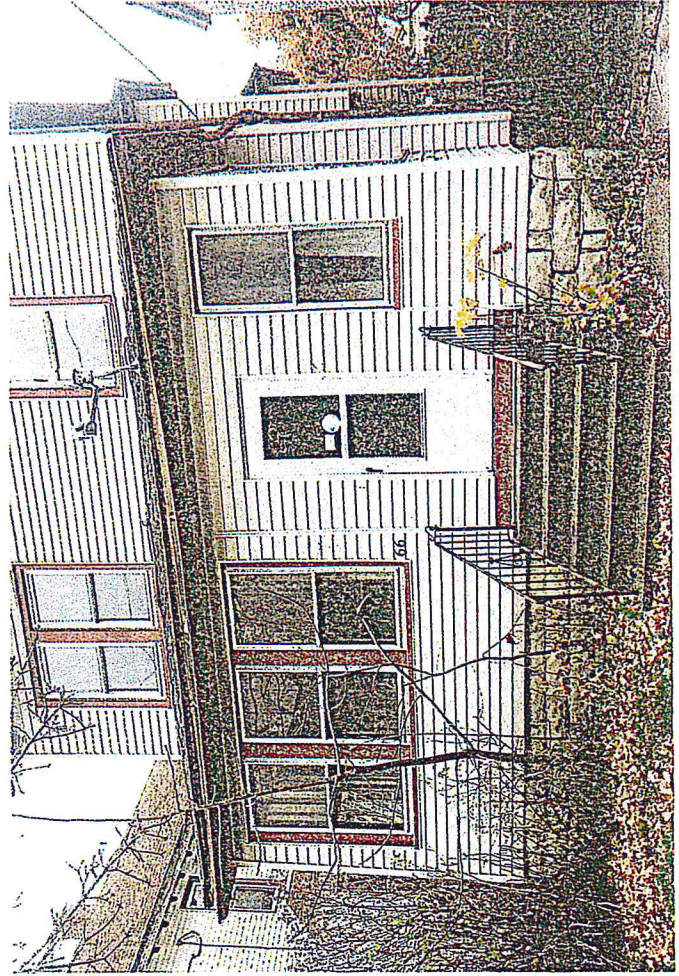
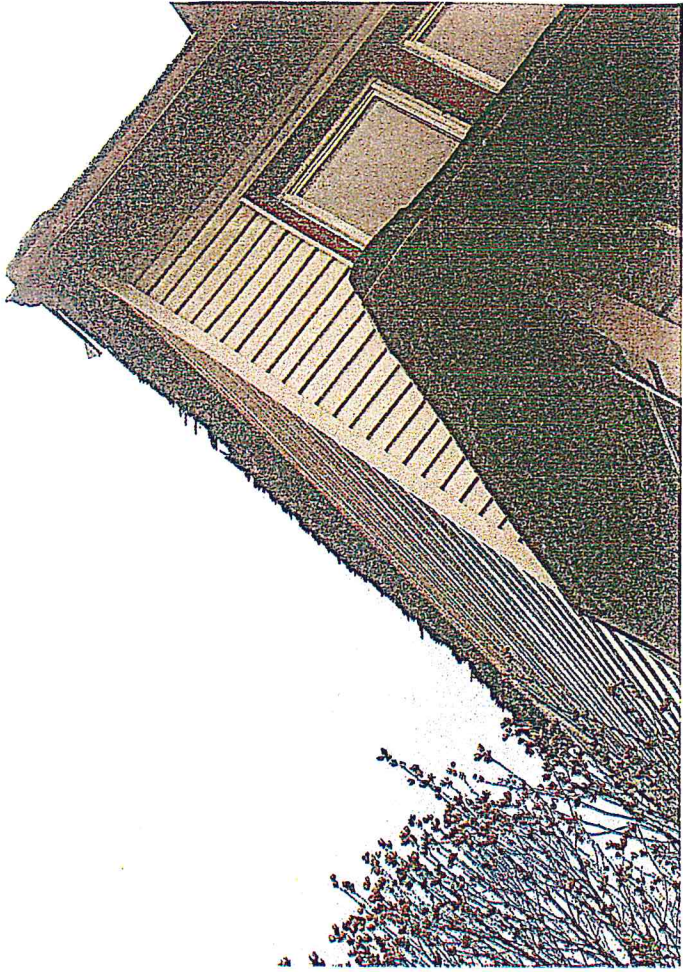
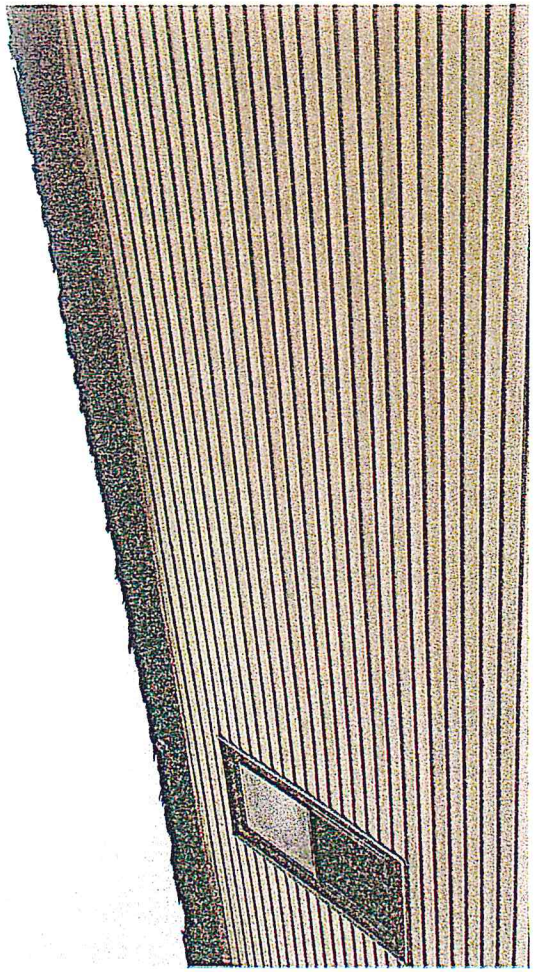
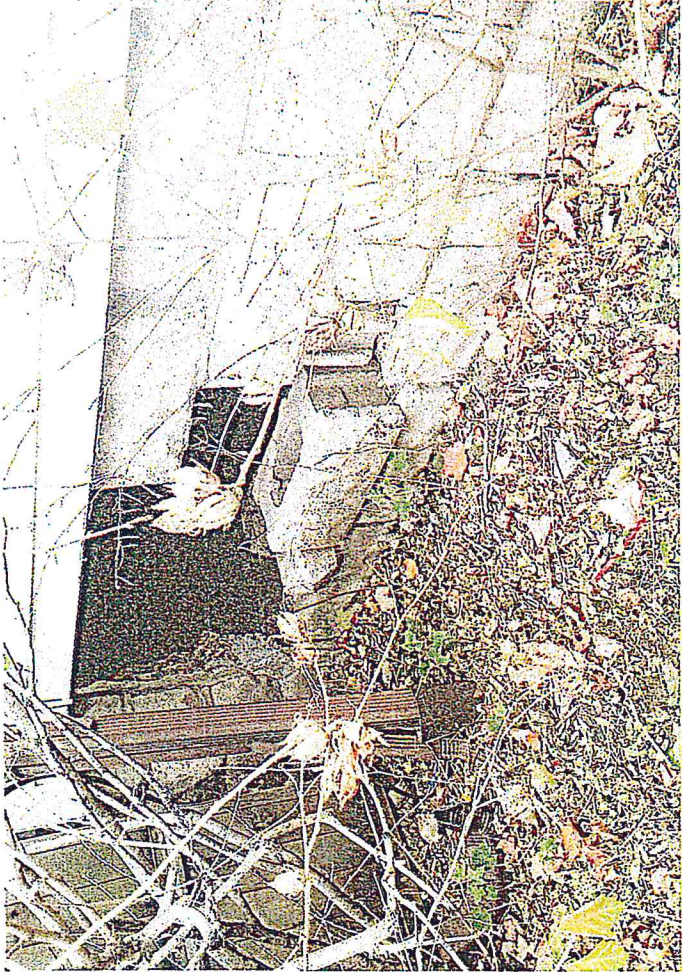
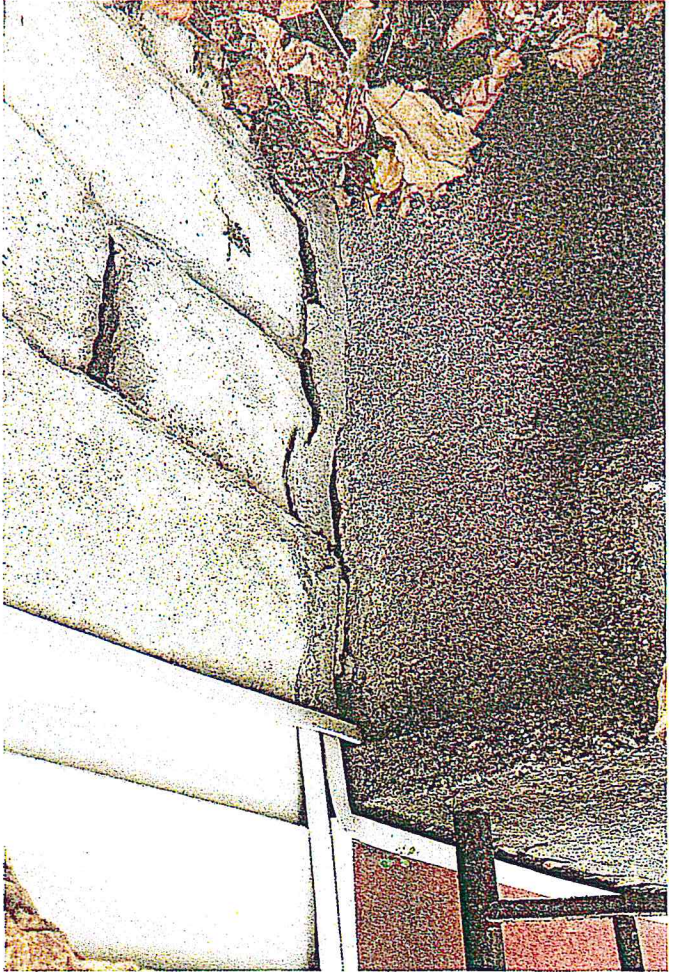
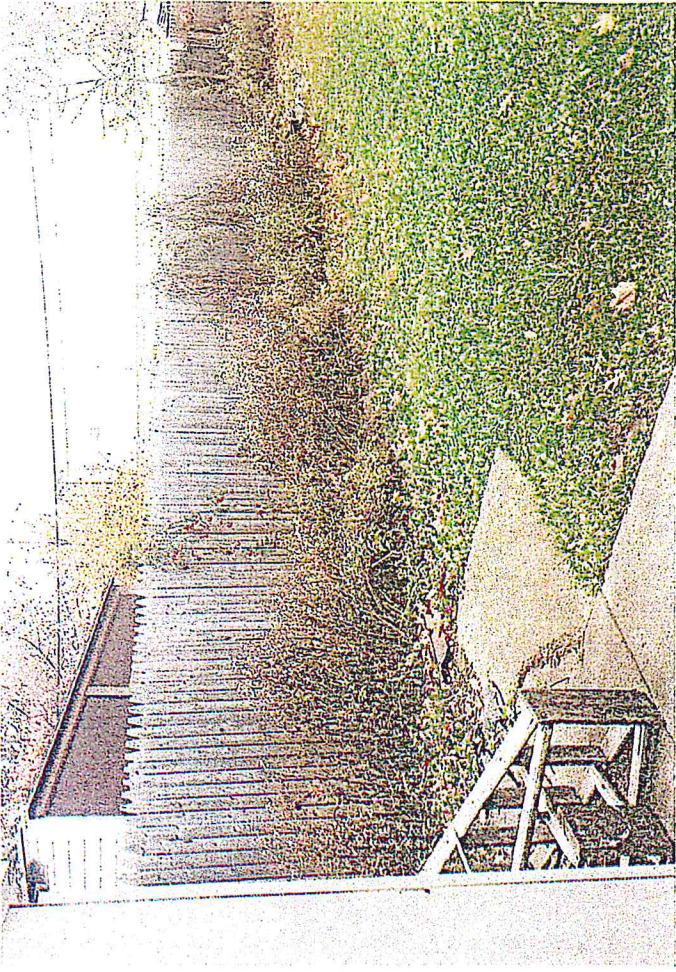
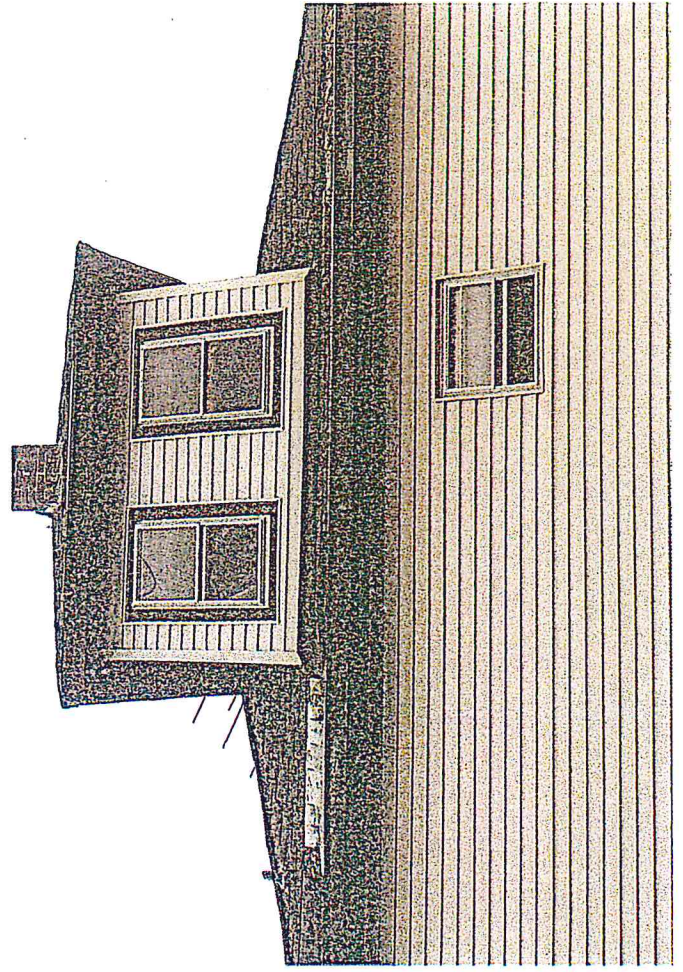
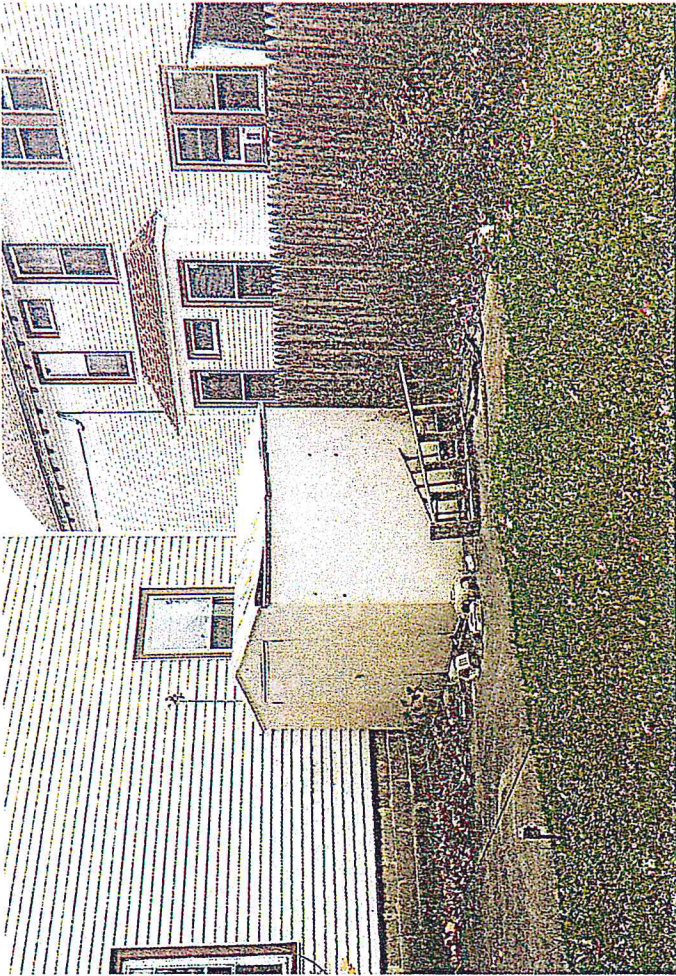
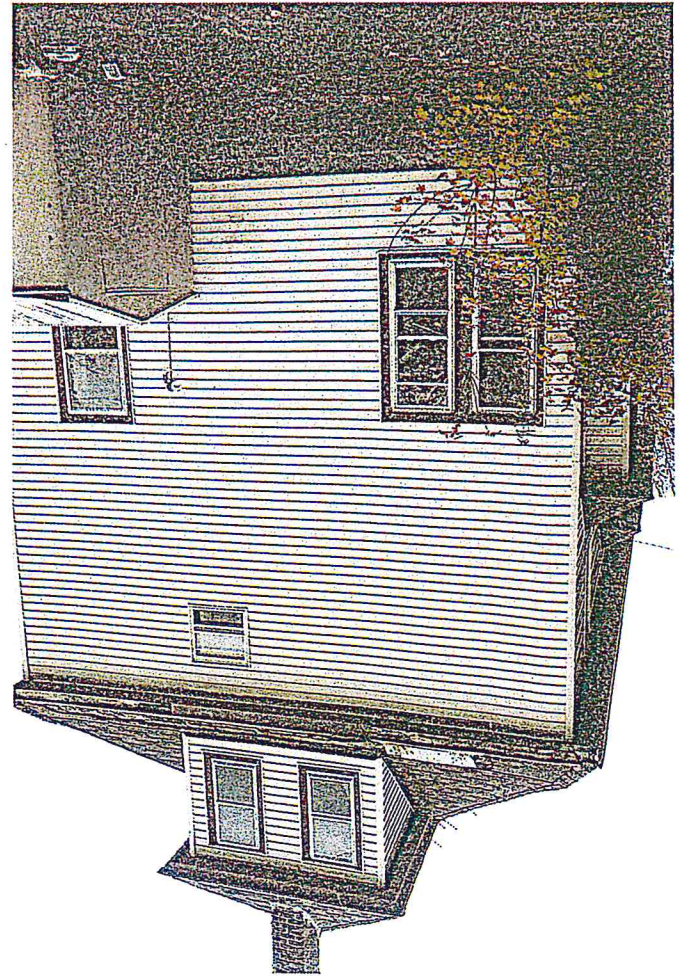
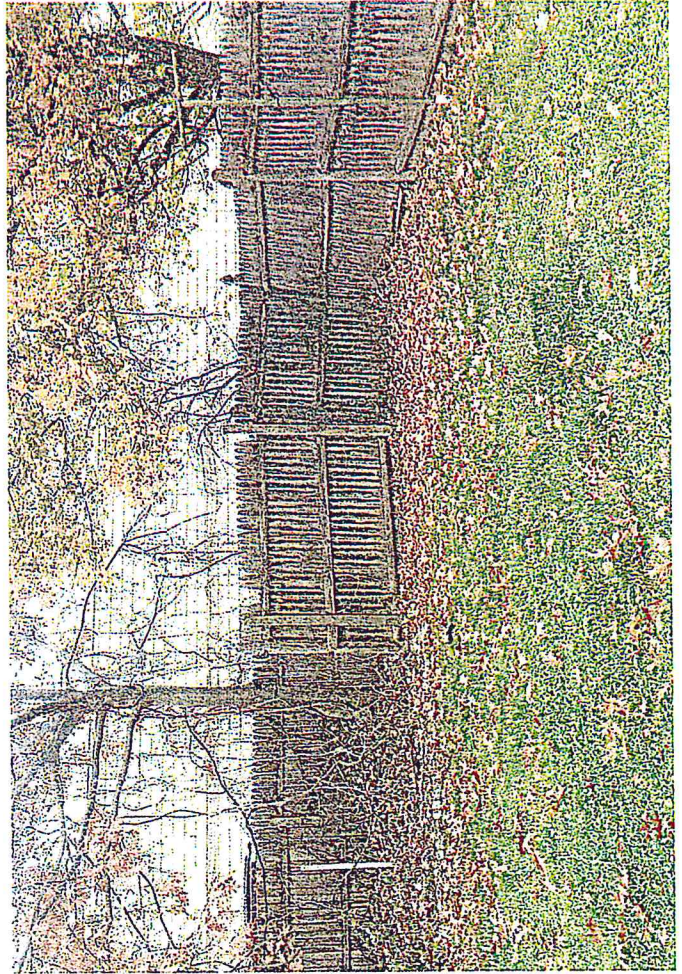
66 Birch Ave 1110115

Roof In Disrepair (See Section: Town Code 92-6 D)
Foundation Failing Permit Ror Repair Req (See Section: Town Code 92-6 C)
Exposed Wood Not Protected (See Section: Town Code 92-6(A))
Downspouts and Gutters In Disrepair (See Section: Town Code 92-4(A))
Missing Windows/Broken Windows (See Section: NYS P.M.C. 304.13)
Fence Does Not Meet Zoning Laws (See Section: Town Code 120-39(B))
Brush Grass and/or Weeds Too High (See Section: Town Code 54-3)
Unsanitary Conditions Exist
